# LAKE HOUSATONIC DAM AND DIKE

CT 00026

## PHASE I INSPECTION REPORT NATIONAL DAM INSPECTION PROGRAM

AUGUST 1981

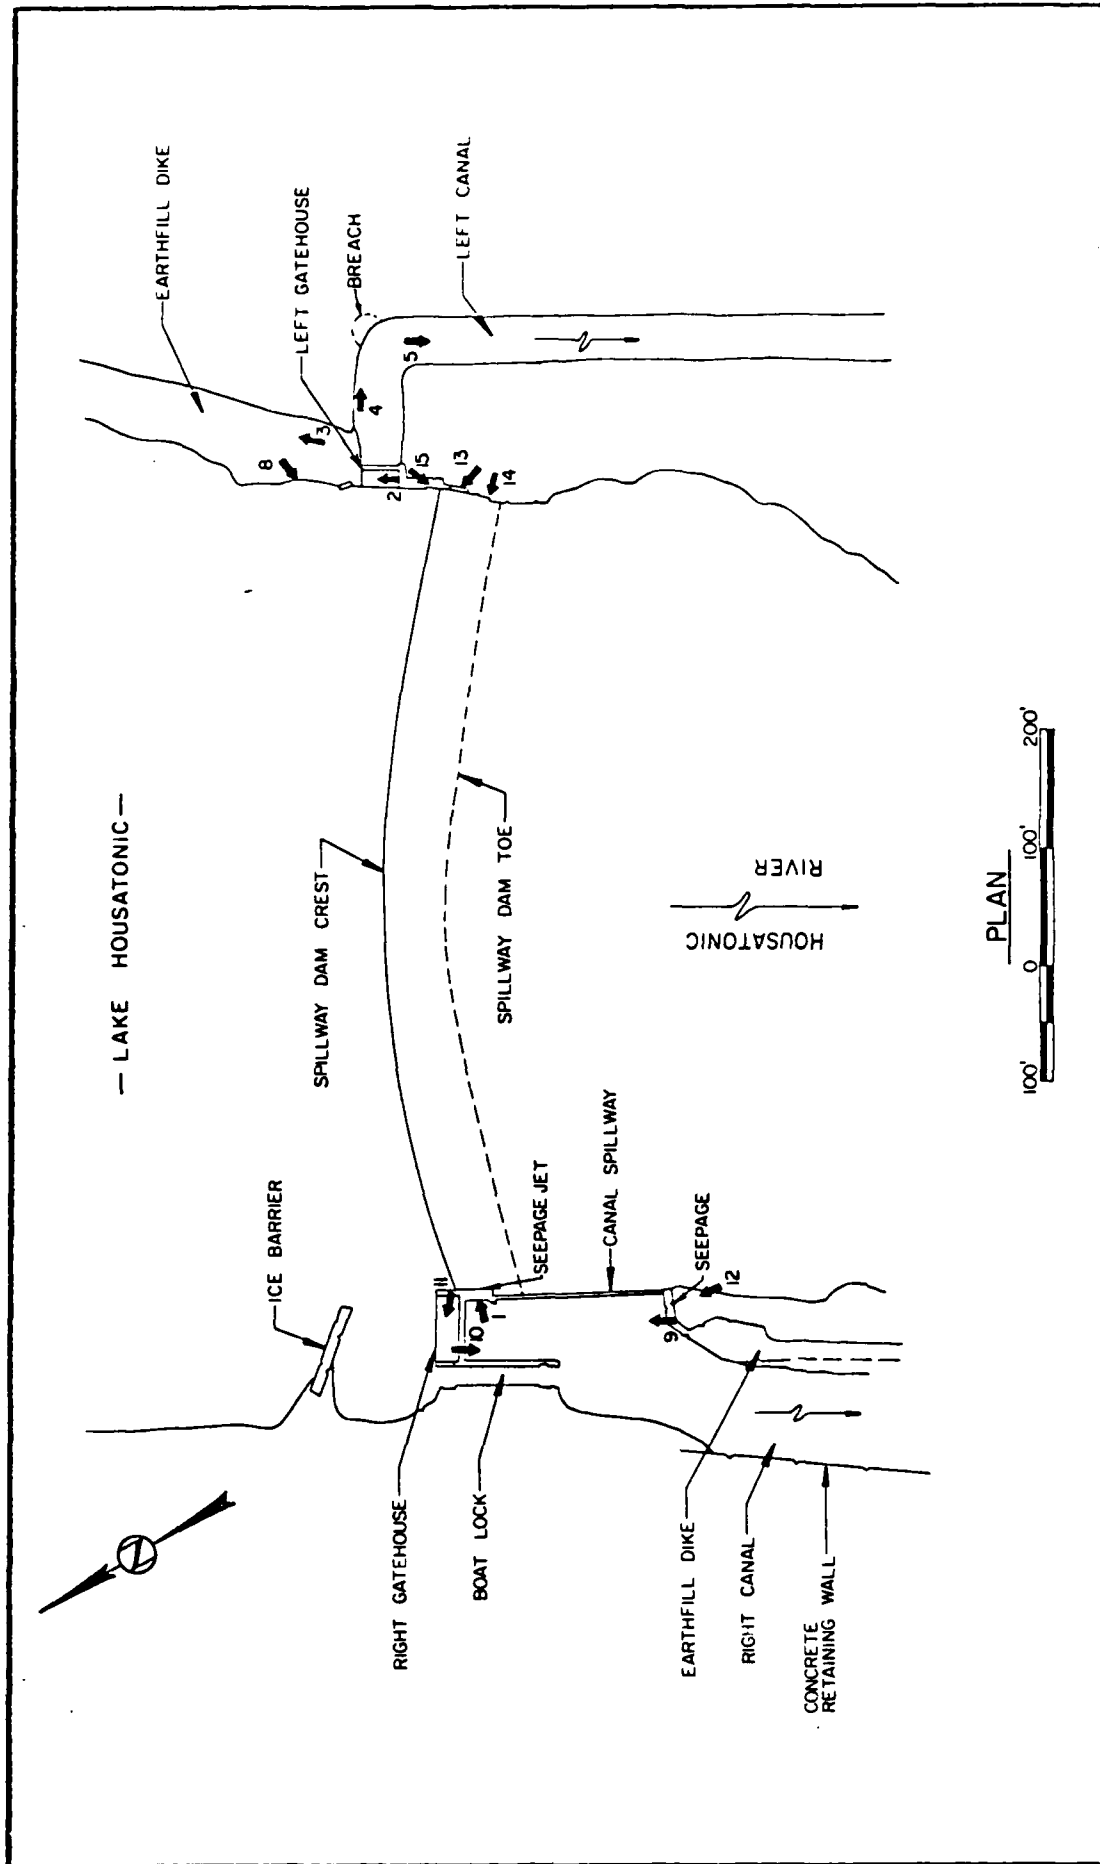
The left gatehouse (Photo 1) superstructure and substructure appeared to be sound, and no signs of cracking or differential settlement were noted. However, efflorescence was noted on the foundation and the

Photo 1 Left Gatehouse and downstream apron of main spillway section.

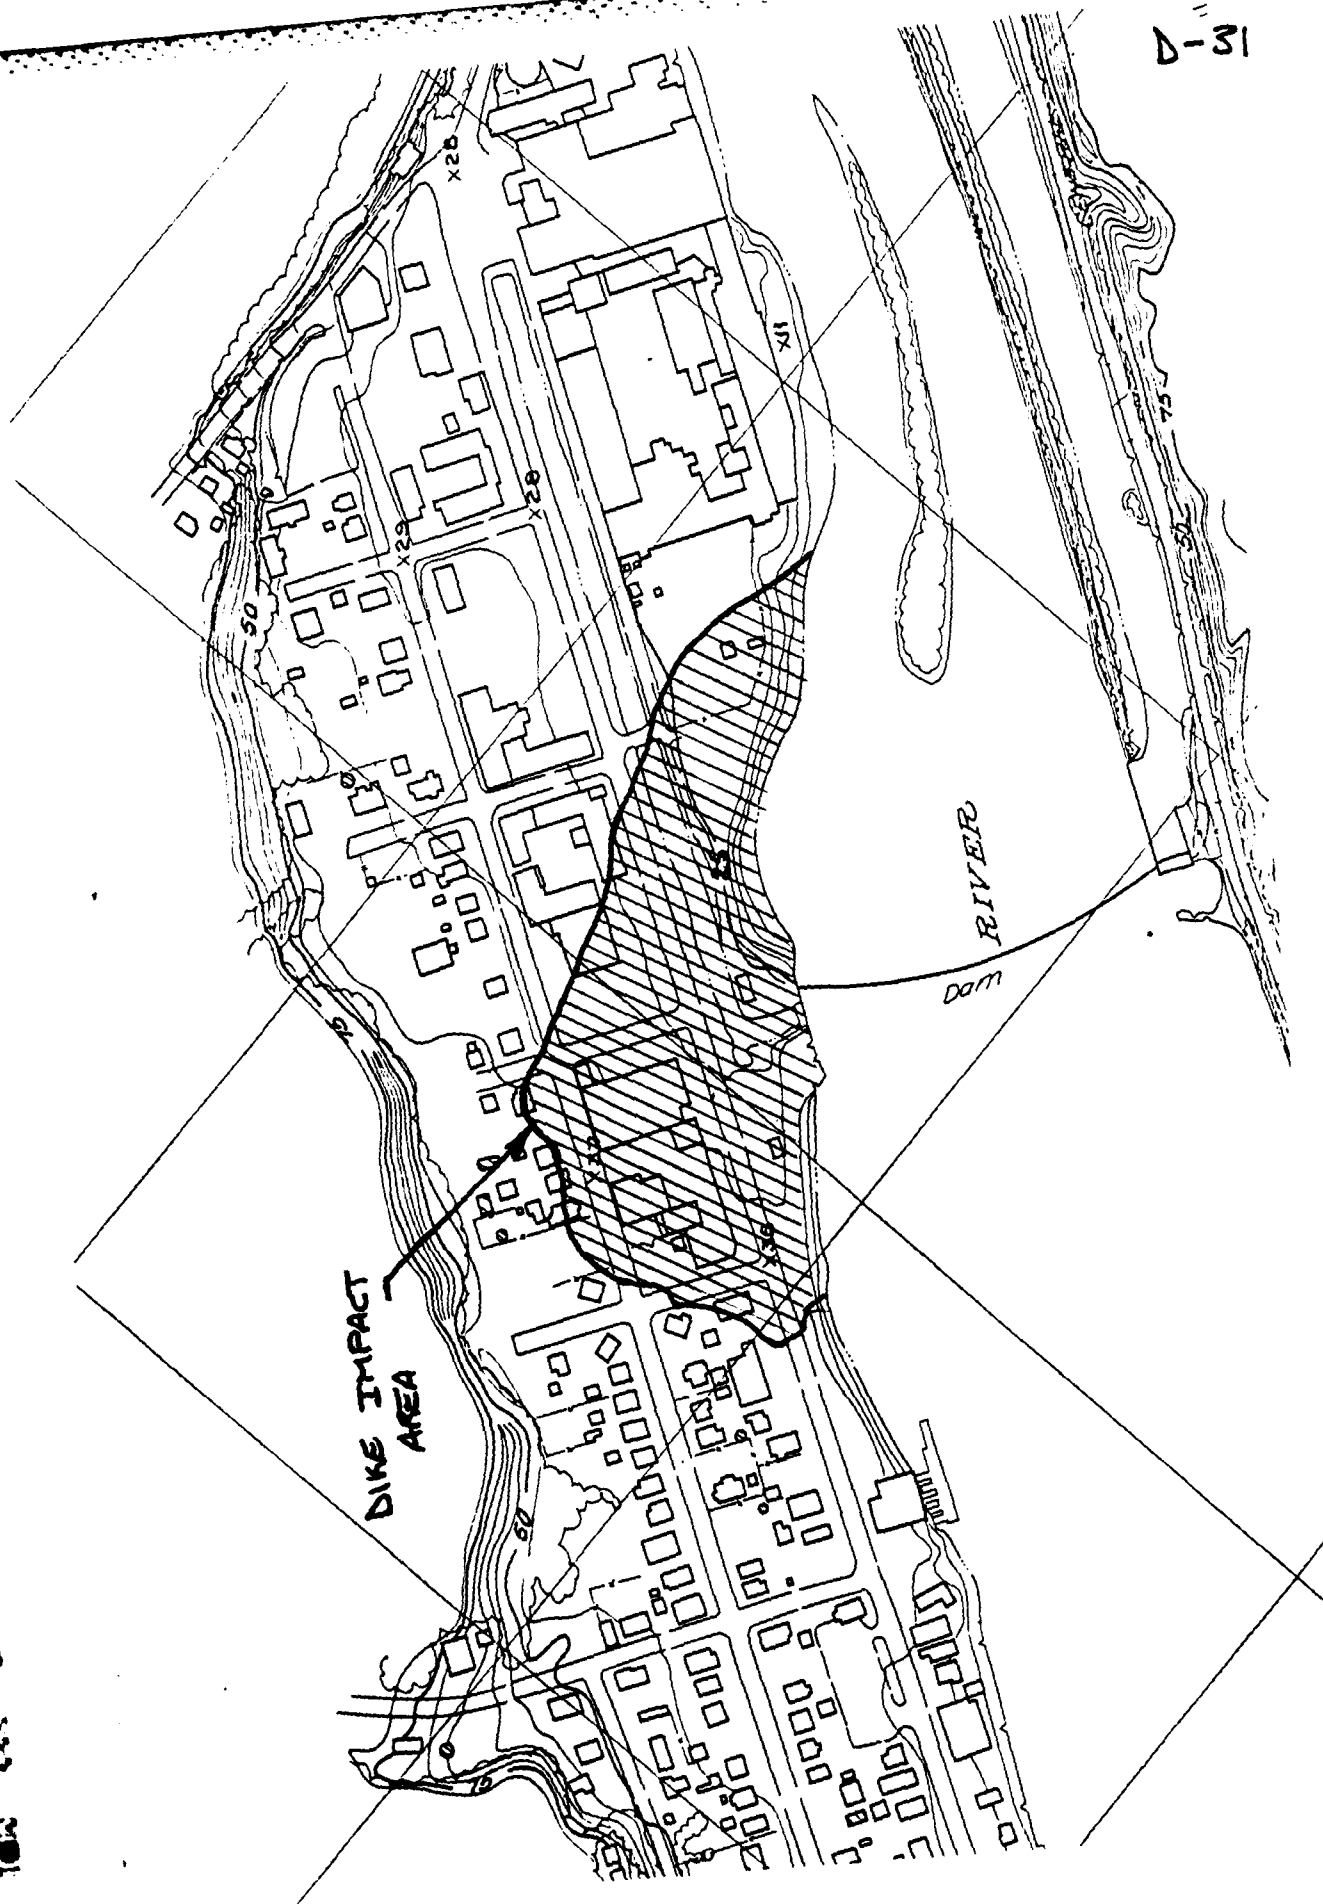
POSSIBLE FAILURE OF DIKE: (SEE P. D-31 FOR PLAN LOCATION)

ASSUMING TOP OF DAM AT ELEVATION 40, FLOW WILL OCCUR OVER A PORTION OF THE DIKE UPSTREAM OF THE LEFT ABUTMENT AND GATE HOUSE. IF FAILURE OCCURS, A SURGE WILL CROSS ROOSEVELT DRIVE APPROXIMATELY 4 TO 5 FEET IN HEIGHT ABOVE STREET LEVEL TRAVELLING AT ROUGHLY 10-15 FEET/SEC; IMPACT WITH THE BUILDINGS 150' TO 200' FROM THE DIKE WILL BE SEVERE CAUSING CONSIDERABLE DAMAGE. INITIAL SURGE WATER MAY EXCEED THE LEVEL OF THE ~~DAM~~ TEMPORARILY BECAUSE OF REFLECTION OF THE WAVE, ~~AND~~ RUNUP OF THE WAVE UPGRADE, AND <sup>SUDDEN CHANGES IN</sup> ~~A~~ MOMENTUM ARISING FROM IMPACTS. QUANTIFICATION OF THIS PHENOMENON IS BEYOND THE SCOPE OF A PHASE I STUDY.

ASSUMING EVACUATION OF AREAS AFFECTED BY ~~PRE~~ PRE-FAILURE DISCHARGE FLOODING DOWNSTREAM, A SUDDEN FAILURE OF THE DIKE IS DEEMED TO BE MORE SERIOUS. THE HAZARD IS HIGH SINCE MAXIMUM PRE-FAILURE STAGES <sup>ELEVATION</sup> ARE BELOW THE POTENTIAL IMPACT AREA <sup>ELEVATION</sup> (274) AS OPPOSED TO POSSIBLE, TRANSIENT STAGES DUE TO
